Sneath's Mill, Lutton Gowt, near Long Sutton, Lincolnshire

Application for Listed Building Consent to Undertake Urgent works

Justification Statement

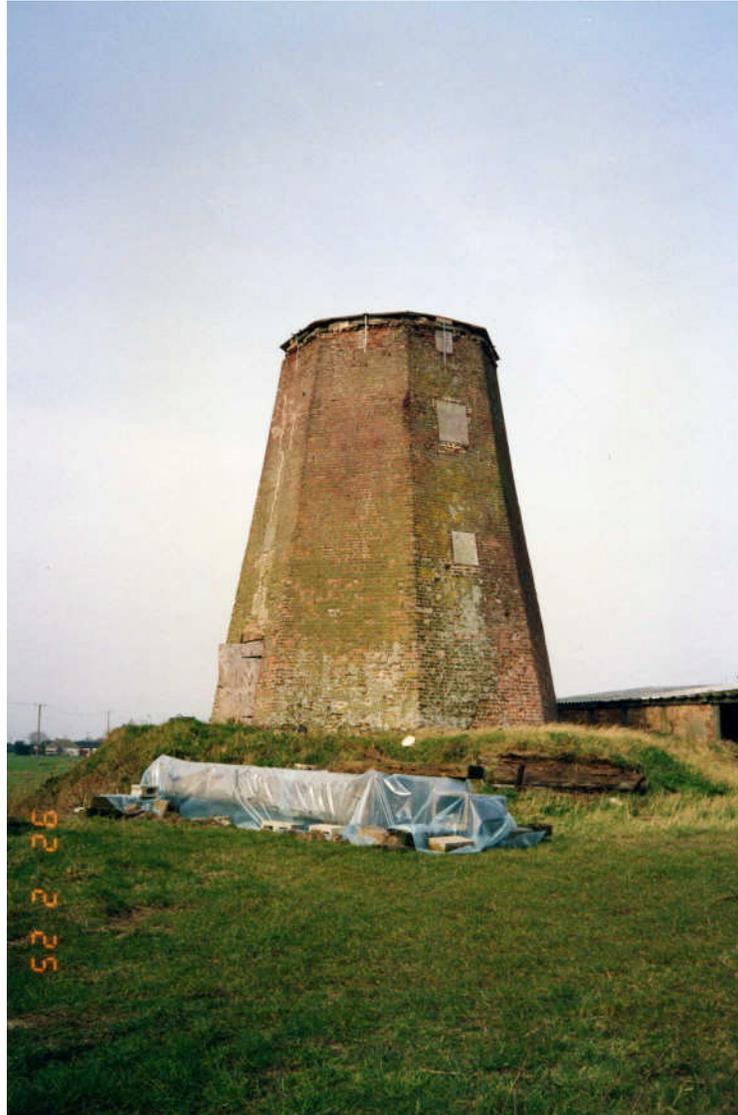
The building has been empty and deteriorating for a considerable number of years and was last recorded as working in 1923. By 1953 it was derelict. It is thought that some temporary works were undertaken in the 1980s with a grant from English Heritage. At that time a temporary ply cap to the roof was installed. (Plate 1) There are now only fragmentary remains of the cap and the mill and its important machinery are suffering rapid decay as a result.

Sneath's Mill in 1992 showing temporary ply cap in place

- 2.2 When full high level access is available allow to remove remains of temporary roof and dispose of from site. Provisionally allow to carefully take down and rebuild 4 courses of brickwork at the head of the tower to create a stable base to support new temporary roof. Note: when the access is available the exact extent or removal/rebuilding will require to be agreed with the CA and with the Local Planning Authority. The emphasis will be on keeping as much as possible of the existing. Photographs are to be taken prior to work commencing on this element and provided to the CA/Employer as part of the record. The rebuilt work must precisely match the details found at high level in terms of corbelling or dog tothing of brickwork. [An alternative approach will be to record the brick detailing and set all or some of the removed bricks aside for later reuse, leaving a fully consolidated level base from which to build up the temporary roof.]

- 2.2 A new temporary roof is to be constructed as per drawing 10245/A3/SK01. Ensure that gaps are galvanised wire meshed to prevent pigeon etc access.

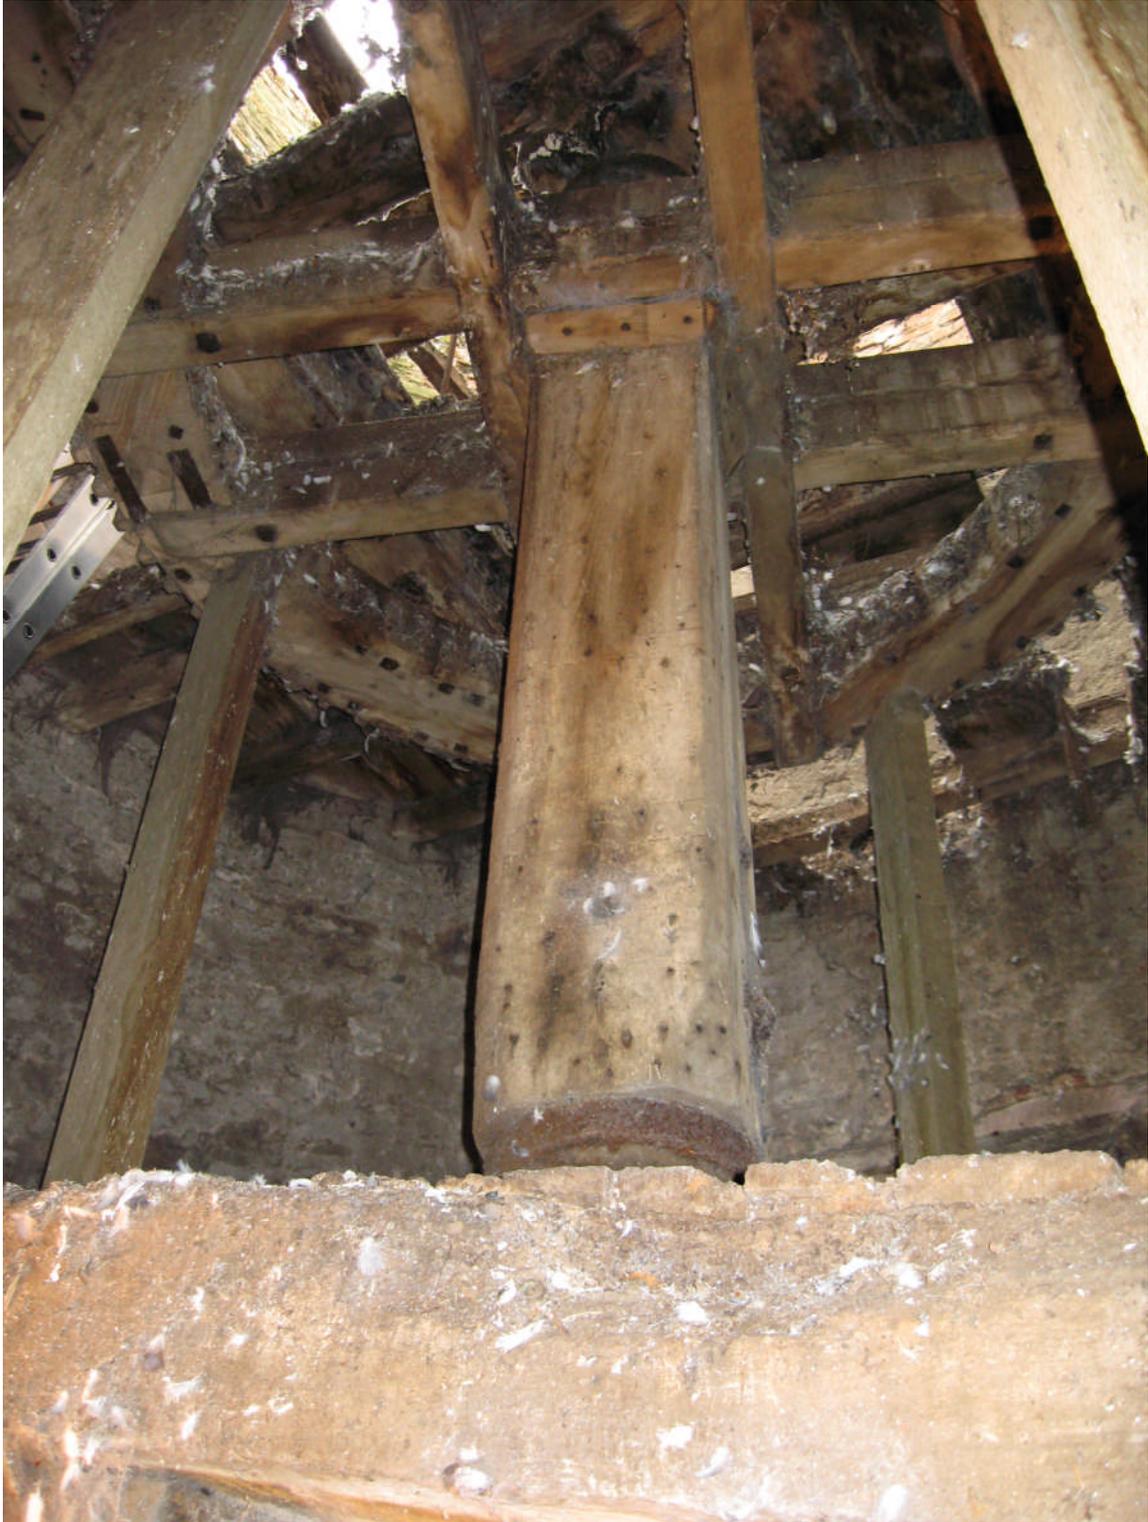
Plate 2: Interior showing pigeon guano on all surfaces

- 1.6 Clear away all guano internally from floor and off all higher level floor levels, (Plate 2) once internal scaffold in place and using appropriate PPE. Ensure all existing timber props remain fully supported as work proceeds. Ensure that any loose fabric or objects found on the floors, which may appear to be part of the

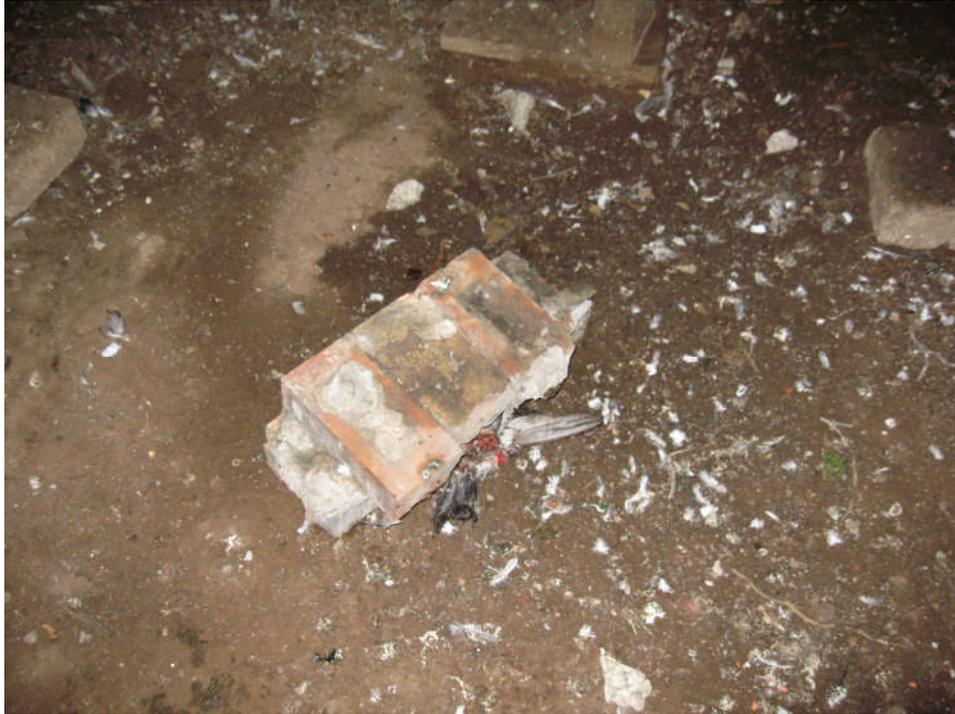
The mill structure is the last Grade I mill in the county of Lincolnshire to remain in a derelict condition. It is one of the earliest surviving mills in the county and of considerable interest not only because of its age and unusual form but also because of its surviving machinery. It is imperative that urgent works are undertaken both to ensure that this rapid deterioration is halted and to enable safe access to the interior of the structure so that the fabric of the mill and its machinery can be studied, assessed, understood and recorded. The presence of pigeon guano on floors at all levels (Plate 2) and evidence that high level brickwork is loose and liable to fall (Plate 3) means that no internal survey work can be carried out until these works are undertaken.

Plate 3: Fallen brickwork from high level showing risk to working internally

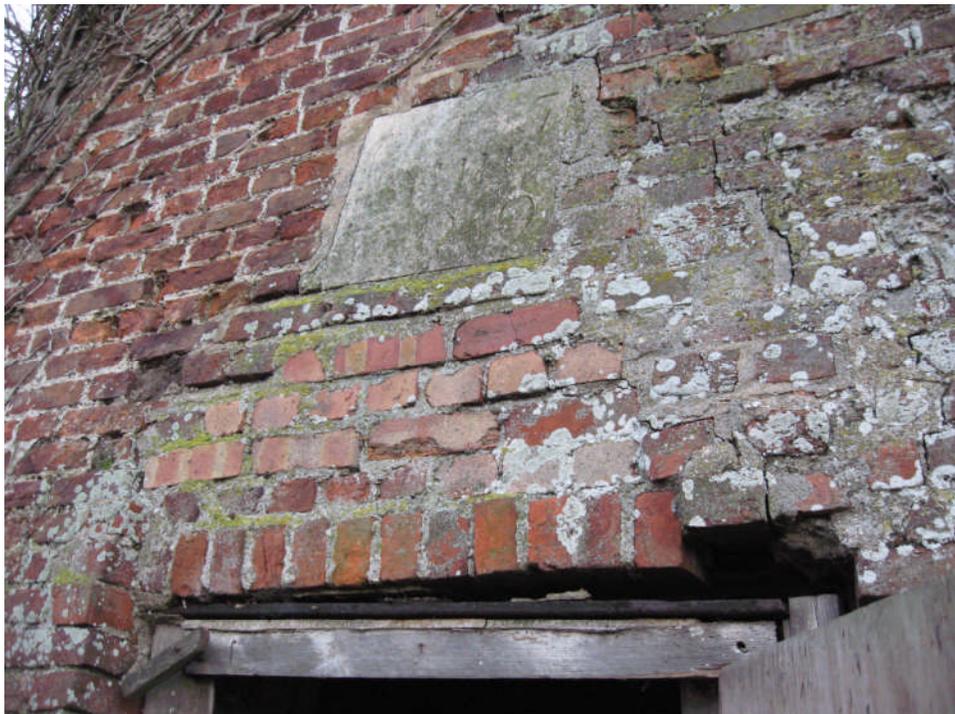
Plate 4: Displaced iron flat and poor brickwork over door may require rebuilding in order to achieve new secure door and frame

[Alternatively, if on close examination it is found that a secure temporary door cannot be achieved due to the condition of the lintel with displaced iron flat under, and failed brickwork above, (Plate 4) allow to prop and remove the existing lintel and replace with a new oak lintel of matching section and to consolidate brickwork above, possibly replacing existing commons with new handmade bricks to match original brickwork. All to be reinstated as shown on Plate 5. Provide new treated softwood door frame of the same size as the existing, and supply and fit a substantial planked permanent door, with top, mid and bottom ledges, to match the door shown on earlier photograph, complete with two substantial strap blacksmith made plain black painted steel hinges. Provide stout secure padlock and hasp.]

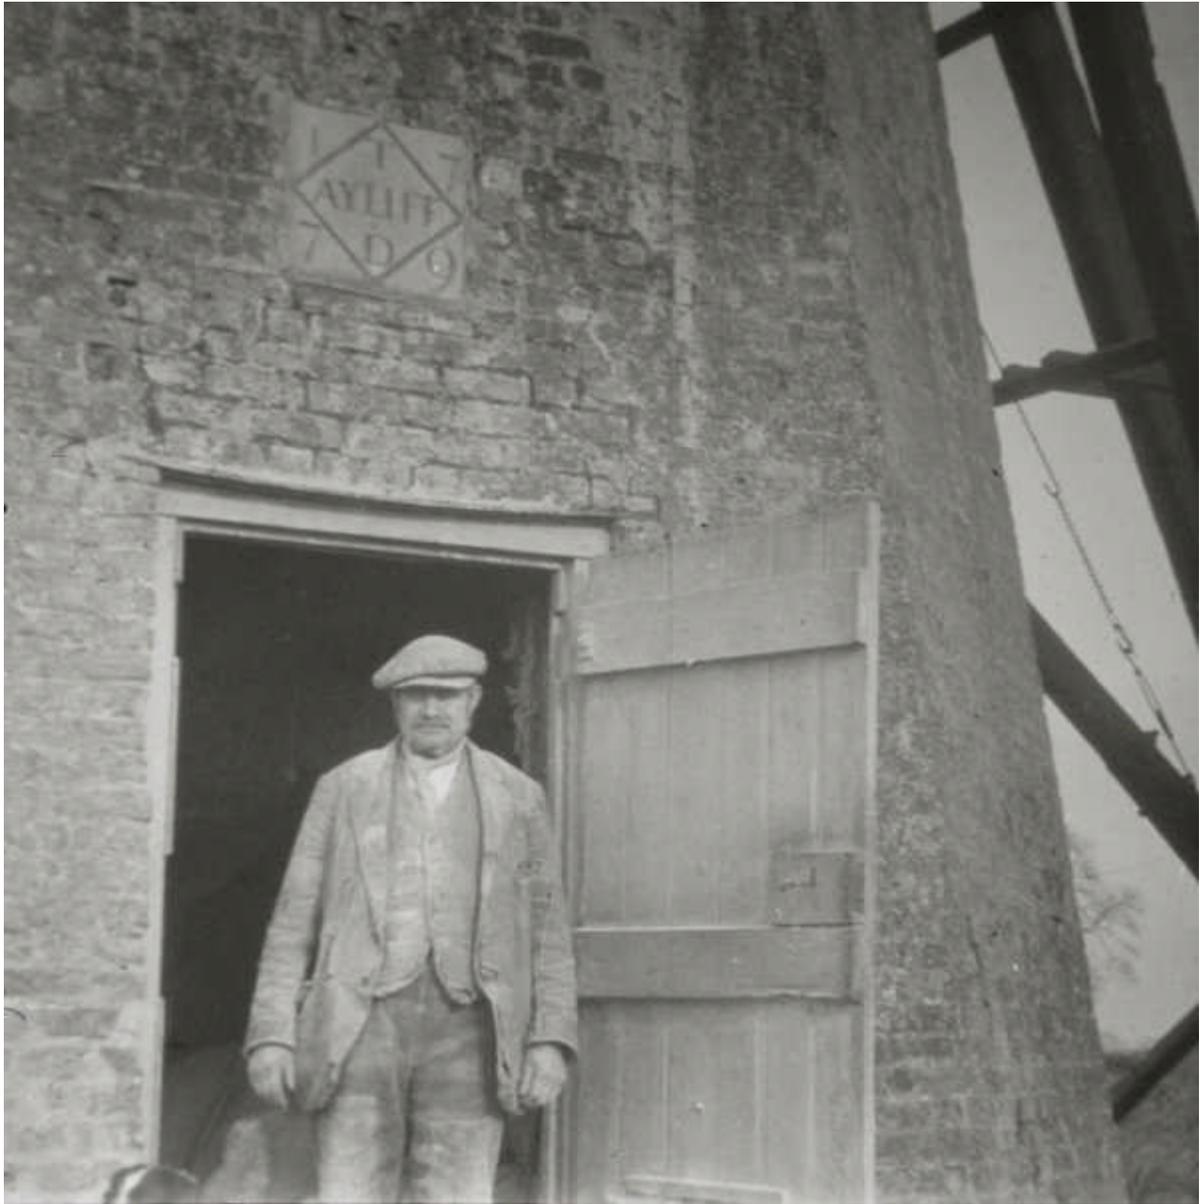
**Plate 5: The original door to the mill; note iron flat and original brickwork above.
© 2003 Mills Archive Trust**

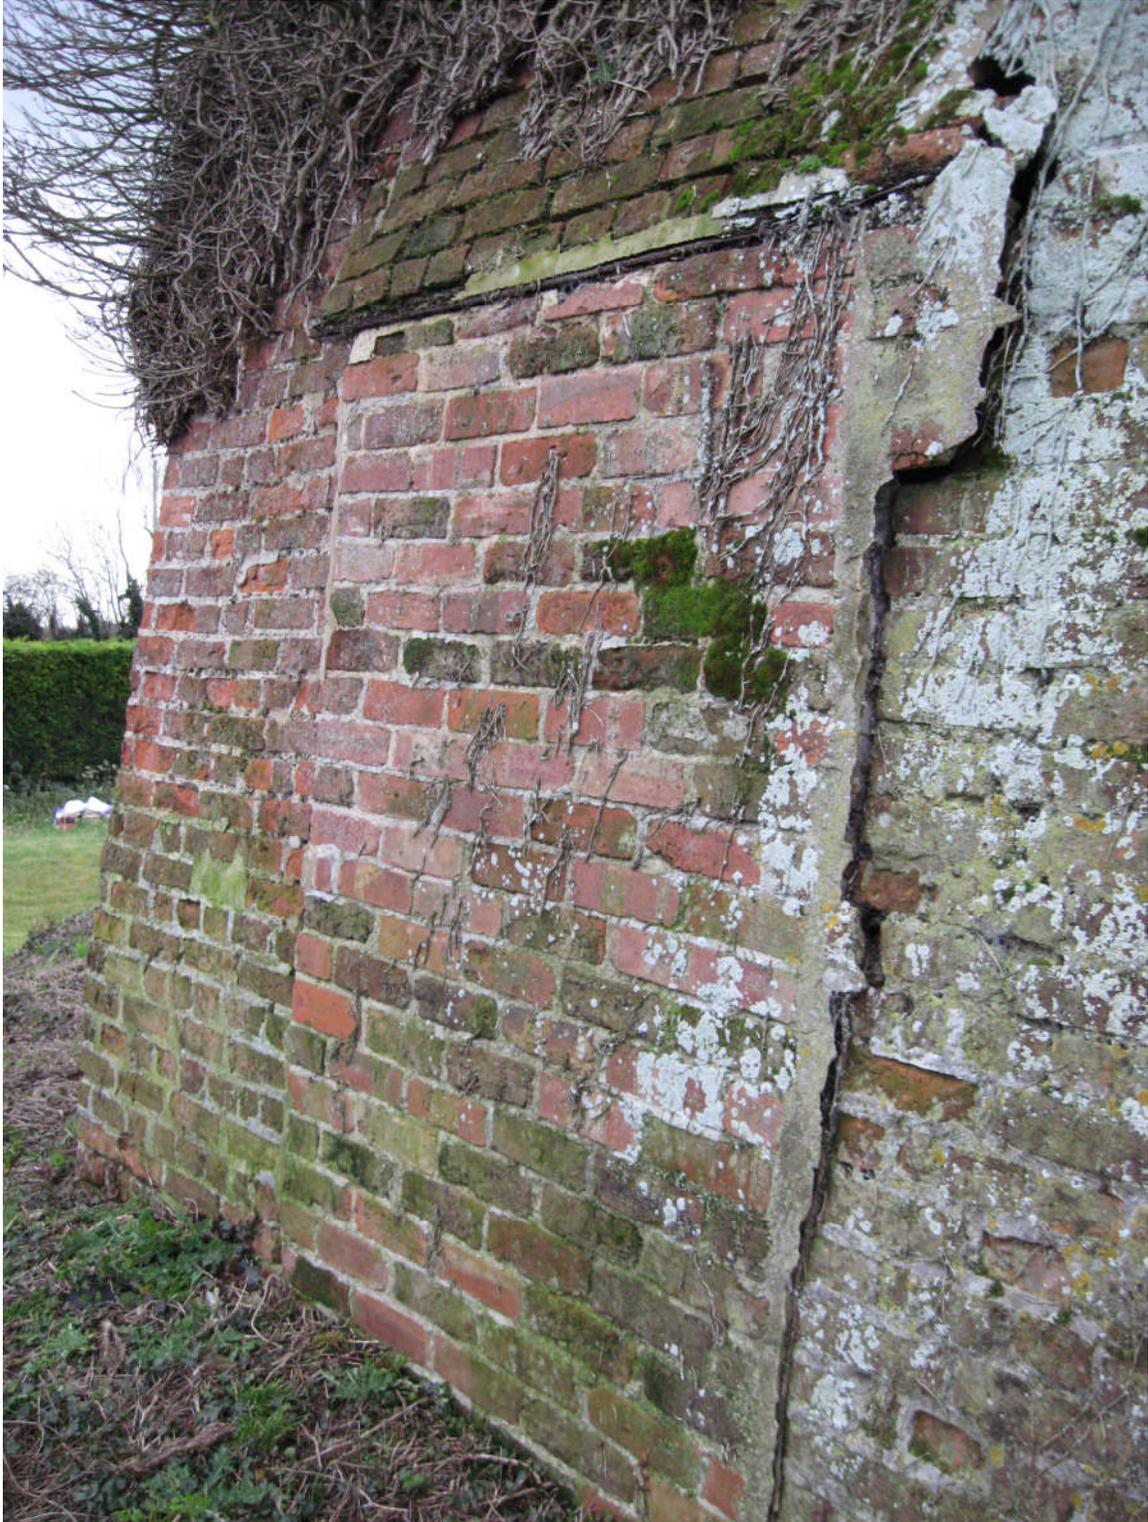
Plate 6: This panel may need propping or taking out and replacing with temporary panel to prop bulged brickwork above.

- 2.8 Allow to prop the blocking to the north doorway to prevent collapse. (Plate 6)

[If the brick blocking to the north doorway has become further detached and is now unstable, allow to dismantle, and take the bricks into agreed store for later rebuilding. Prop the masonry above using a temporary stout wooden frame clad both sides with 18mm ply and include also for raking struts and board to support the bulging brickwork above, if required by structural engineer]
