SNEATH'S MILL
LONG SUTTON
LINCOLNSHIRE

ARCHAEOLOGICAL ASSESSMENT

REPORT
AUGUST 2010

SITE CODE: LGS08
REPORT CODE: FAS2010 461 LGS369
NGR: TF 4358 2429

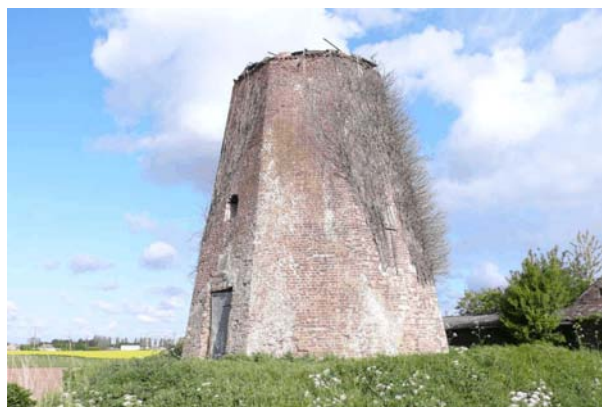
Plate 1 Sneath's Mill looking northwest

Sneath's Mill lies to the south of the settlement of Lutton Gowts, in the northern part of the parish of Long Sutton in southern Lincolnshire (NGR: TF 4358 2429; Figure 1). The mill site is largely surrounded by agricultural land although there has been more recent residential development to the east (Plate 1). There are three buildings on site; the central mill tower on its mound, to the south lies a mid-20th century barn, while to the north lies a group of ancillary buildings. All of the buildings are in poor structural condition.

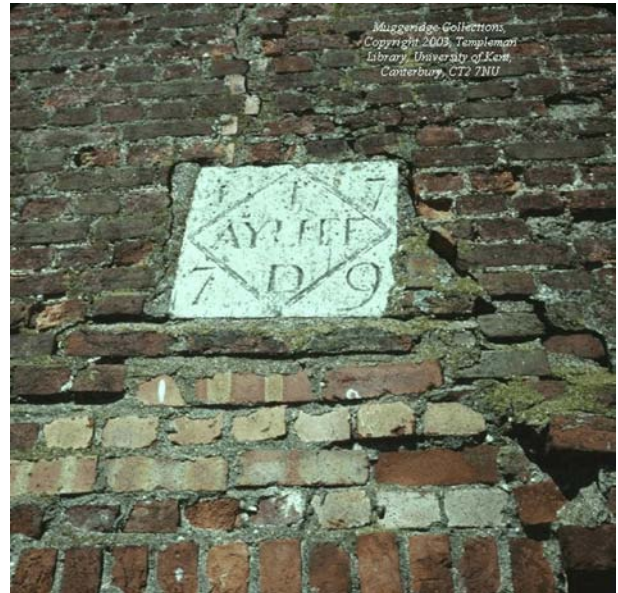
Plate 2 Inscribed stone above the doorway (Mugg 1978/4)

Thomas Ayliffe’s mark can be found on the fabric of the standing building. A stone above the door is inscribed with ‘1779. T.D. Ayliff’ (Plate 2). Sass (1978, 62) states that this stone used to be a sundial. Ayliffe’s name is also found on the first floor beam facing the entrance ‘Thomas Ay...’, which also bears the inscription ‘IOH...RAM’. The latter letters may form part of the name ‘Hillram’; the lower half of an upright shaft in the floor is carved ‘T.A. 1779’ and ‘T.Oliver, W.Hillram 1783’ (Sass 1978, 65).

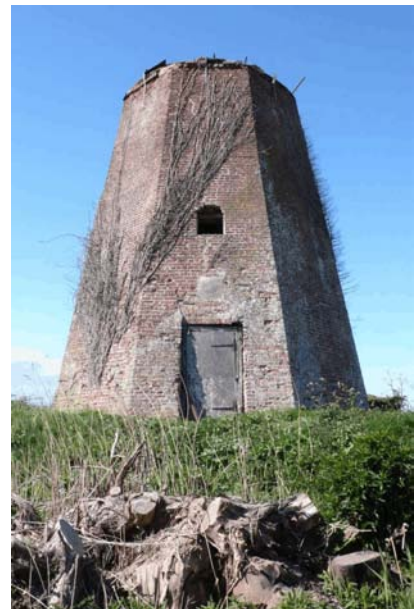
Plate 5 The south facet of the mill tower

The southern facet contains the main doorway at ground-floor level (Plate 5). The head of the door opening has been subject to some alteration being now formed by bricks laid as headers and a patch of replacement brick

above. However, there are some traces for an angled springing either side of the doorway, suggesting either a more elegant brick arch or possibly a stone lintel was originally employed. Above the door opening is a square stone which has T. D. Ayliff 1779 inscribed upon it, the date numbers located towards the corners of the stone. Mid-20th-century photographs indicate that the stone was painted with the lettering picked out in a dark colour and a diamond design around the name. It has been suggested that the stone formed a sundial but this seems unlikely.

At first-floor level is a small square window opening that has suffered a partial collapse of its head. It is now devoid of any window frame or glazing, but appears to have originally been a two-over-two light horizontal sliding sash. A further window appears to have been provided at second-floor level, but the opening has been blocked in brick.

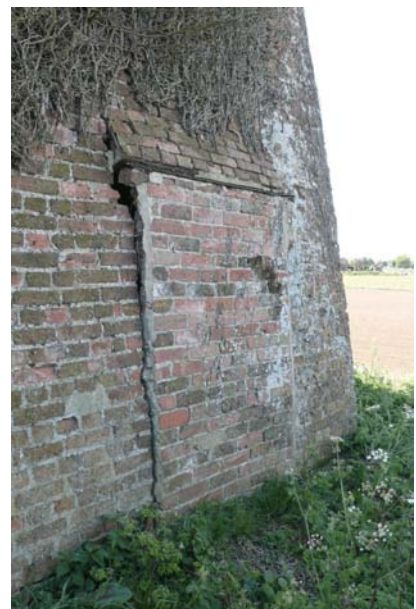
Plate 6 The north facet of the mill tower

The northwest facet has no features of note, but the north facet contains a further door at ground-floor level (Plate 6). The opening has been blocked, a post-disuse addition, although the blocking is in the process of being pushed out by movement of the structure. The head of the doorway is also suffering a similar problem, with its timber lintel and the brickwork above deflected. Like the southern door opening, there is some evidence that the door head has been reformed. There are window openings at first- and second-floor level, currently hidden by a carpet of dead ivy. The window at second-floor level has been blocked; the brick blocking inserted before the 1930s. The first floor window was square and had a four light window in a timber frame; it is possible that this remains *in situ* under a board covering.

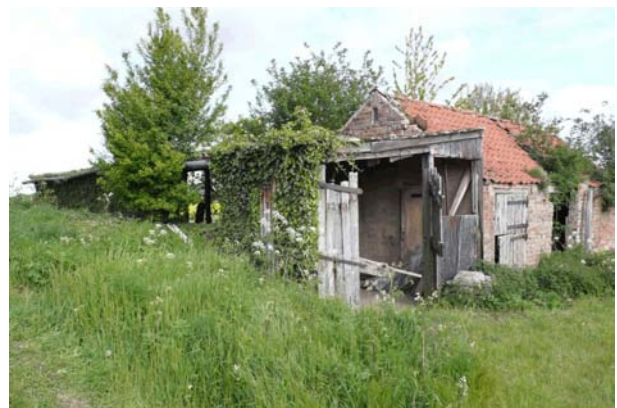
Plate 7 The ancillary building to the south

To the north of the windmill tower is a single storey complex of buildings which has developed over time (Plate 7). The structure that is closest to the mill tower, a large shed, is timber-framed with some brick infilled panels and a mono-pitched roof of a mixture of materials including corrugated asbestos. The east elevation has been provided with a pair of timber doors mounted on strap hinges, while the some of the panels have been infilled with corrugated iron. Internally, there is further evidence for the development of the building, with all walls unplastered apart from that forming the party wall

with the structure to the north, which also has a door opening within it. This would suggest that originally the building was smaller, but was subsequently expanded to the west between 1888 and 1932.

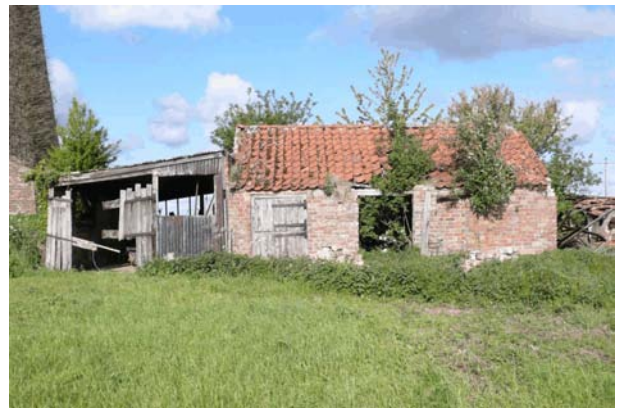
Plate 8 East elevation of the centre building

The centre building is of brick with a pantile roof and has undergone several phases of development. The east elevation has two doorways; that to the south retains a half-door, the other to the north has lost its frame but is of similar proportions (Plate 8). To the north of the latter doorway is a junction in the brickwork where the

building has been extended further to the north. Internally the building has been tiled, masking any junctions in the fabric. In the north wall are a pair of doorways providing access to the building to the north; both doors retain half doors. In the west wall are shuttered square openings, while additional roof lights have been provided in the ceiling.

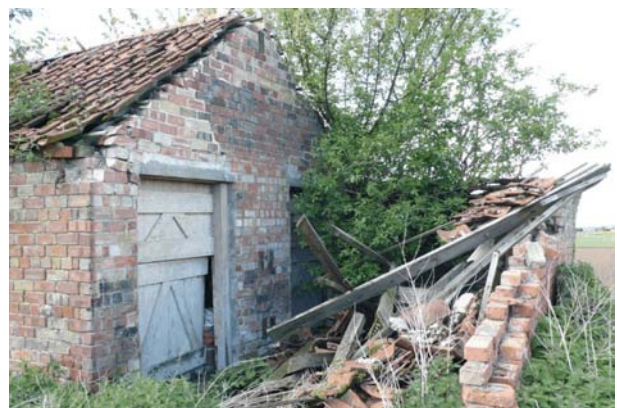
Plate 9 North building

The northernmost building has suffered extensive disintegration, with the east wall largely gone, the remains of the north wall in the process of collapse and the west wall in poor condition (Plate 9). The roof has caved-in but appears to have followed the pitch and form of the centre building, covered with pan-tiles. The remains of divider on the south wall suggests that the building was internally divided into two stalls for keeping stock or horses.

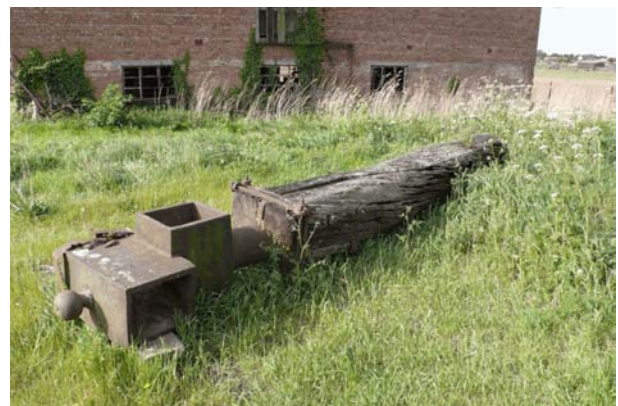
Plate 11 Windshaft and iron canister

The sail stocks were mounted on the windshaft *via* a cast-iron canister or poll end. Rex Wailes (1953) noted that the windshaft was the largest in a Lincolnshire windmill. Currently the oak wind shaft, complete with canister lies on the ground to the adjacent to the mill (Plate 11). The canister is fixed to the windshaft by a long iron tongue which has been bolted through and strapped with wrought iron. The canister has been finished with a ball finial in its centre. The brakewheel, which would have been mounted on the windshaft, is absent.

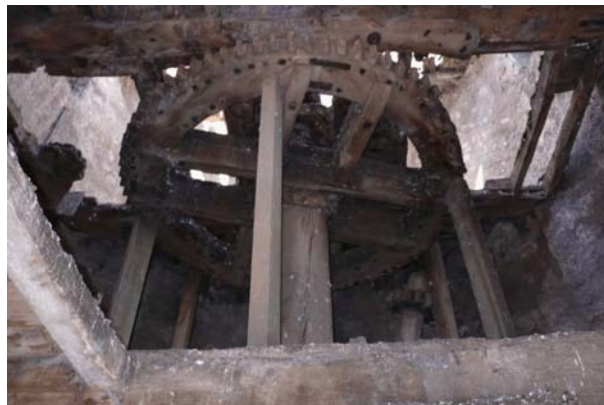
Plate 12 Upright shaft and great spur wheel

The timber upright shaft remains in position within the mill and is *c.*0.3m square (Plate 12). The shaft passes down through the dust and bin floors and is supported on the stone floor (first floor). According to Sass it is jointed to its lower half by a 'cross gudgeon of iron' at bin floor level (Sass 1977, 64-5); it is currently not possible to inspect this joint. Sass states that the shaft was renewed after the first world war, but if it is jointed it is possible that replacement was only partial; either the upper or lower half. The bottom of the shaft is located in a bearing in an adjustable sprattle beam.

The great spur wheel remains *in situ* in the building, although supported by props, and is visible from the ground floor (see Plate 12). As with the other gear wheels it is of timber clasp arm construction and *c.*2.3m in diameter. The pitch was established by Sass as being 3 3/4in and consisting of seventy-eight teeth; it is thought to be largest great spur wheel in Lincolnshire (Sass 1977, 65). The survey of the site in 1978 provided colour transparencies of the great spur wheel and upright shaft, now part of the Muggeridge Collection (Mugg 1 and 2).

If it were desired to reinstate the machinery in working order, a reasonable compromise might be to utilise the main surviving elements which appear to be in good, repairable condition. These elements might include the upright shaft and great spur wheel, while re-manufacturing those elements which are absent or would require extensive repair. Elements not used in the reconstruction could be housed on the site as part of an interpretation scheme.

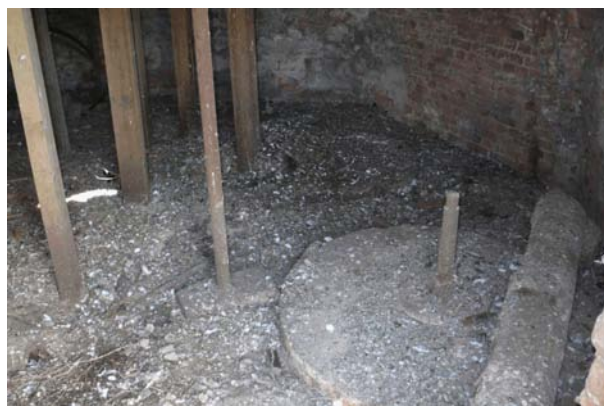
Plate 13 French mill stones remaining the mill tower

There are two stones lying on the ground floor of the mill, detached and presumably lying where they fell from the floor above (Plate 13). Sass (1977, 65) records two pairs of overdriven stones and identified those on the east side as a pair of 4'6" French stones - quartz stones used for mill wheat - with the maker's name plate on the runner, inscribed 'George Marris 1847' and those on the west side as a pair of Peak stones - millstone grit from Derbyshire used for grinding animal feeds. The stones remaining in the building are probably the French stones, since the Peak stones were removed to Penny Hill Mill in Holbeach when the mill fell into disuse.
