SNEATH'S MILL
LONG SUTTON
LINCOLNSHIRE

ARCHAEOLOGICAL ASSESSMENT

REPORT
AUGUST 2010

SITE CODE: LGS08
REPORT CODE: FAS2010 461 LGS369
NGR: TF 4358 2429

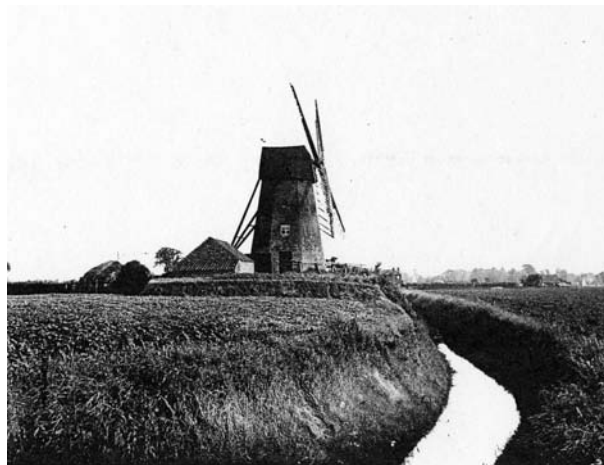
Plate 3 Photograph of the mill taken in June 1936 (NMR AA80/5372)

The mill was still working at the time of a survey in 1923 (Wills 1980, 1). A series of photographs dating to between 1932 and 1936 record the mill at this time (Plate 3).

After the damage caused to the mill by a storm in the 1930s (HER Record 22392), the cost of repairs was too great, and the mill was abandoned. In 1936, the miller was listed as 'John Sneath, Roman Bank, Long Sutton, retired miller', which presumably indicates that the mill had ceased to function at that time.

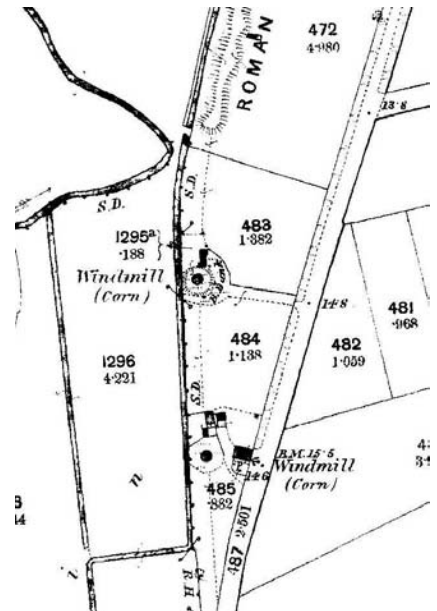
Plate 4 Extract from Ordnance Survey 1888 showing the mill

The earliest plan consulted (1845) shows the mill tower, with a roughly square structure situated in the northern part of the site. The 1888 map shows that this smaller building had been either replaced, or added to, to form a north-south aligned, rectangular building, slightly closer to the tower on the eastern side of the site (Plate 4). This plan persisted into the 20th century (OS 1938), until a large agricultural building was added to the southern part of the site in the 1940s or 1950s.

The intended function of the structure, in its expanded form, appears to have been as a cart shed. The footprint of the original and smaller building can be further established from the 1888 Ordnance Survey map (see Plate 4). This must have constructed between 1845 and 1888 being absent from the earlier tithe map. The fact that the internal walls were originally plastered suggest that it had a slightly more domestic use than a cart shed in this period.

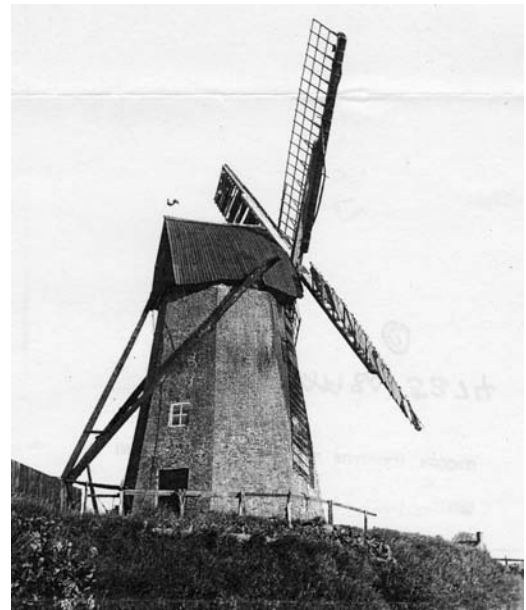
Plate 10 Photograph of the mill taken in June 1935 (NMR AA80/5374)

The cap was boat-shaped and boarded with a weathercock mounted on the brake to inform the miller of the wind direction. Both cap and weathercock were in photographed in position in the 1930s and 1940s (Plate 10). The boat-shaped cap is a design that predated the more common ogee-shaped caps found on Lincolnshire mills. Elements of the cap frame have been returned to the site recently and are located within the shed to the north of the windmill. According to Sass there were two cap frame centring wheels beneath the main sheers at the front and rear (Sass 1977, 64), but these now appear to be absent. The weather beam carried a bearing for the windshaft, while the beam was carried upon a cast-iron chair which had a cast-iron roller between, mounted on the curb. From the ground, the wooden curb can be seen to be in place, but it is not clear whether the iron face plate, that was fixed on top of it, also remains.

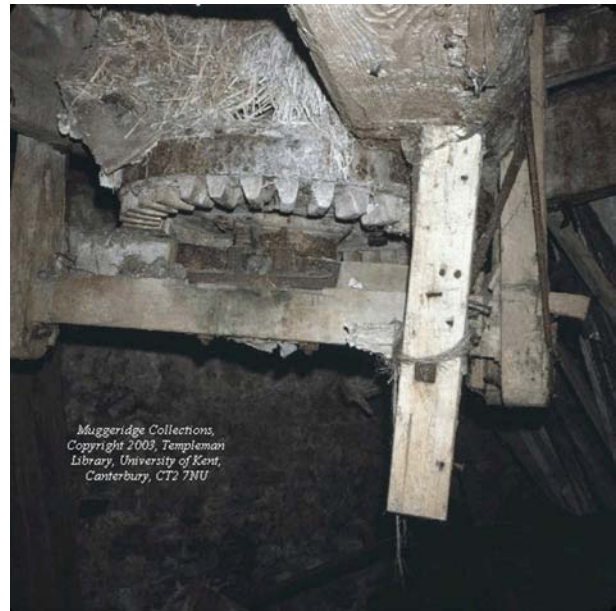
Plate 14 Iron and wooden nut used to drive the flour dresser (Mugg 1978/3)

Much of the flour dresser drive mechanism remains *in situ*, although displaced by the failure of the supporting structure. The actual flour dressing machine, used to separate the flour from the rest of the meal, was missing by the time of the 1975 survey; it was originally fixed to the ceiling of the ground floor. The drive mechanism consists of an iron nut with wooden teeth (1ft 4in in diameter according to Sass), which is mounted on a timber octagonal spindle six inches in diameter. It would have been driven from the northern side of the great spur wheel at stone-floor (first floor) level, but has fallen out of mesh. The spindle passes down to the ground floor where it would have turned a wooden cogged iron bevel gear (2ft 3in in diameter), which remains. The Muggeridge Collection contains a colour plate of the drive to the flour dresser (Plate 14).
